Debris/Ice/TPS Assessment And Integrated Photographic Analysis For Shuttle Mission STS-52

December 1992

DEBRIS/ICE/TPS ASSESSMENT
AND
PHOTOGRAPHIC ANALYSIS
OF
SHUTTLE MISSION STS-52

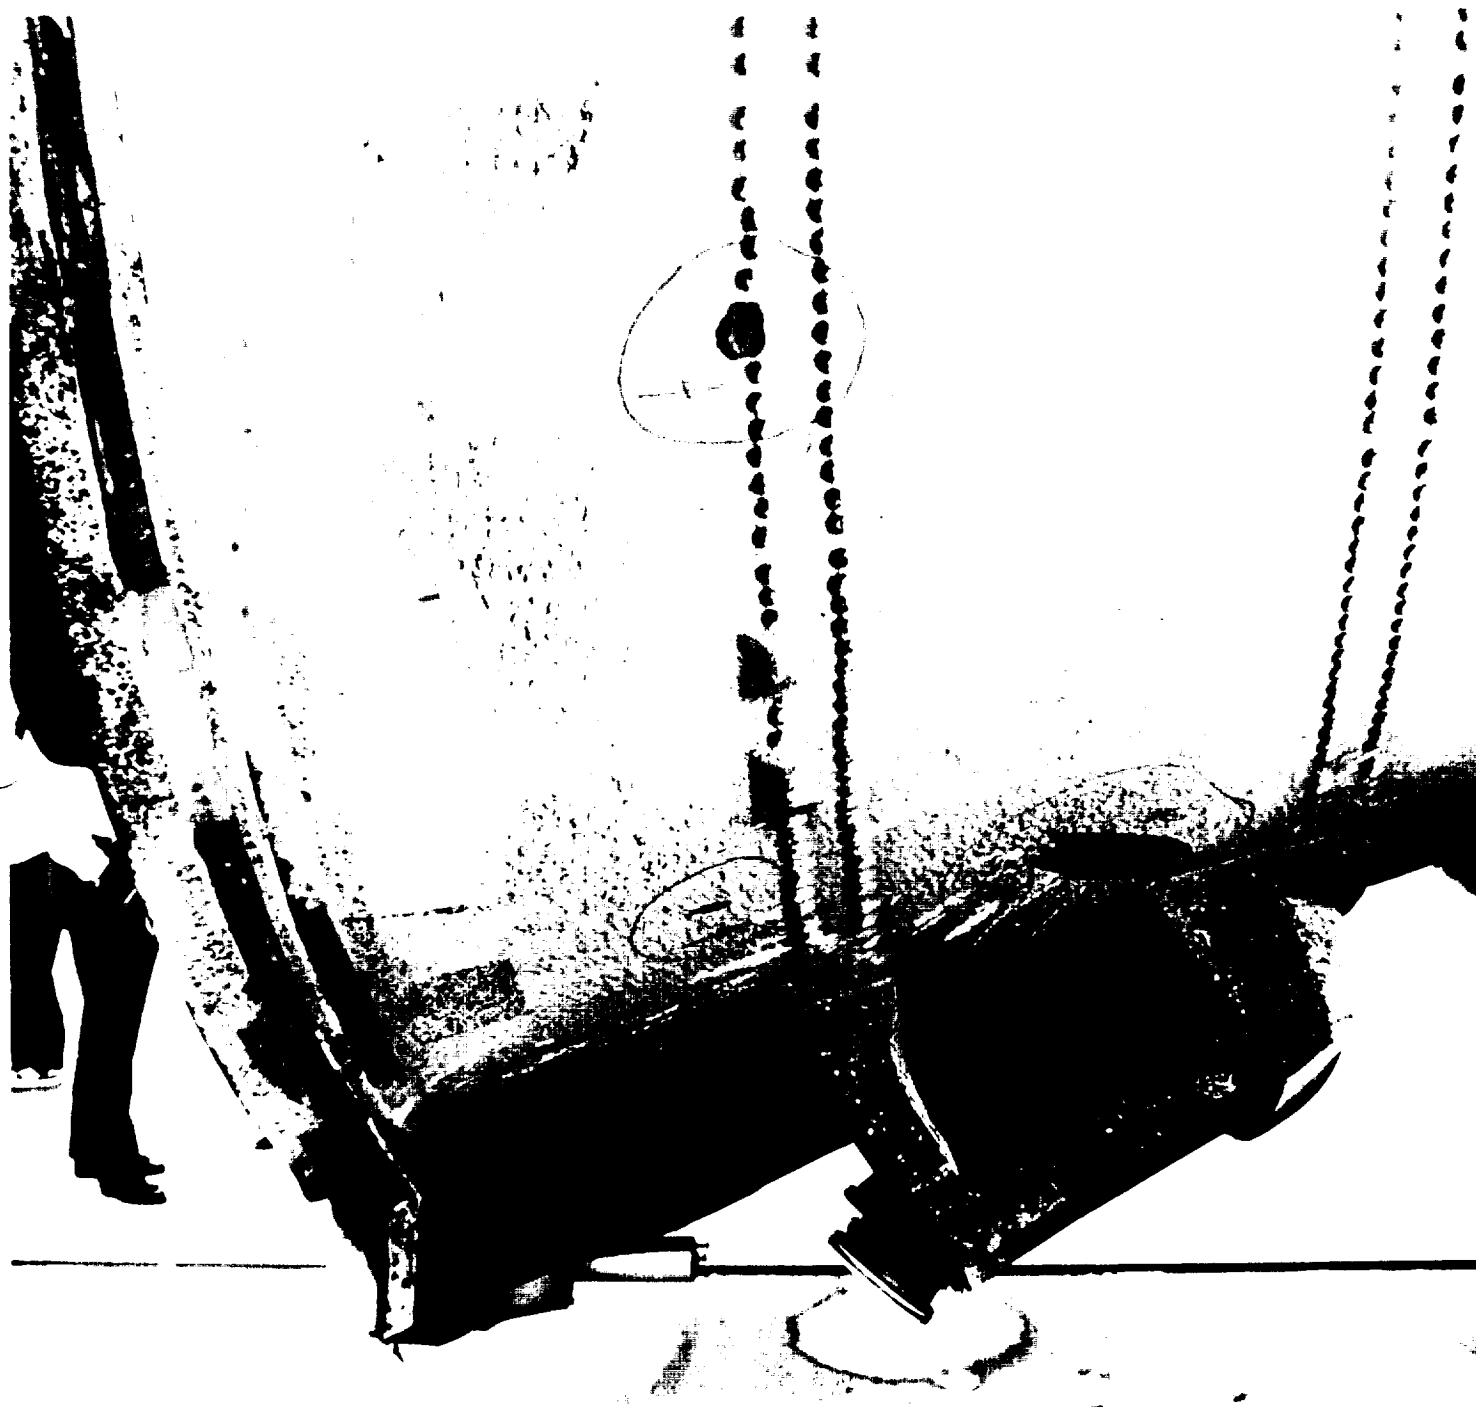
Three divots, one of which exposed two fastener head covers, occurred on the aft skirt acreage TPS near the location of the booster separation motors (BSM's).

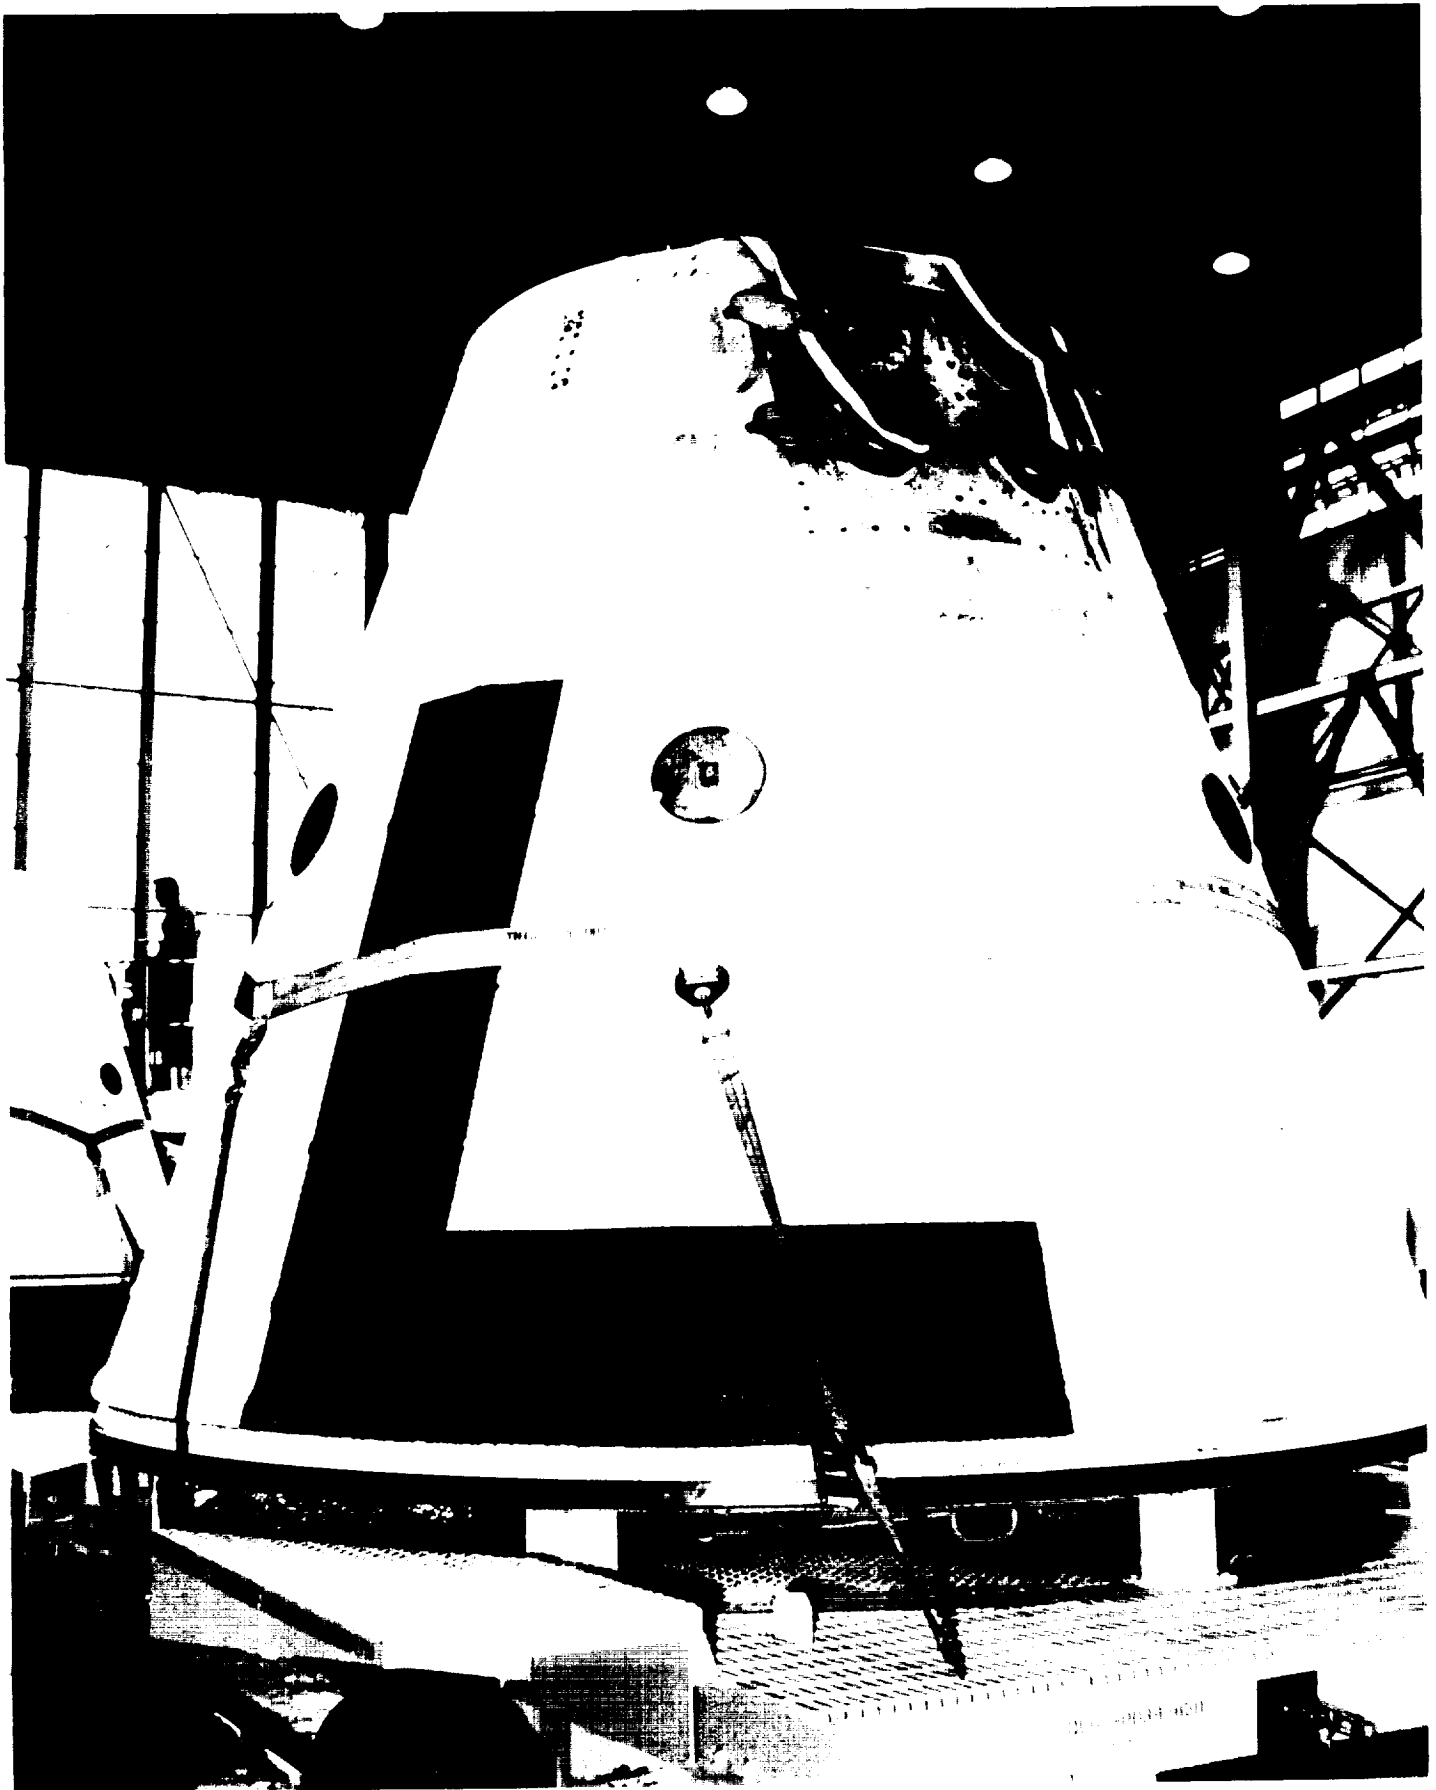
The LH frustum was missing no TPS, but had 27 MSA-2 debonds over fasteners. The BSM aero heat shield covers were locked in the fully opened position.

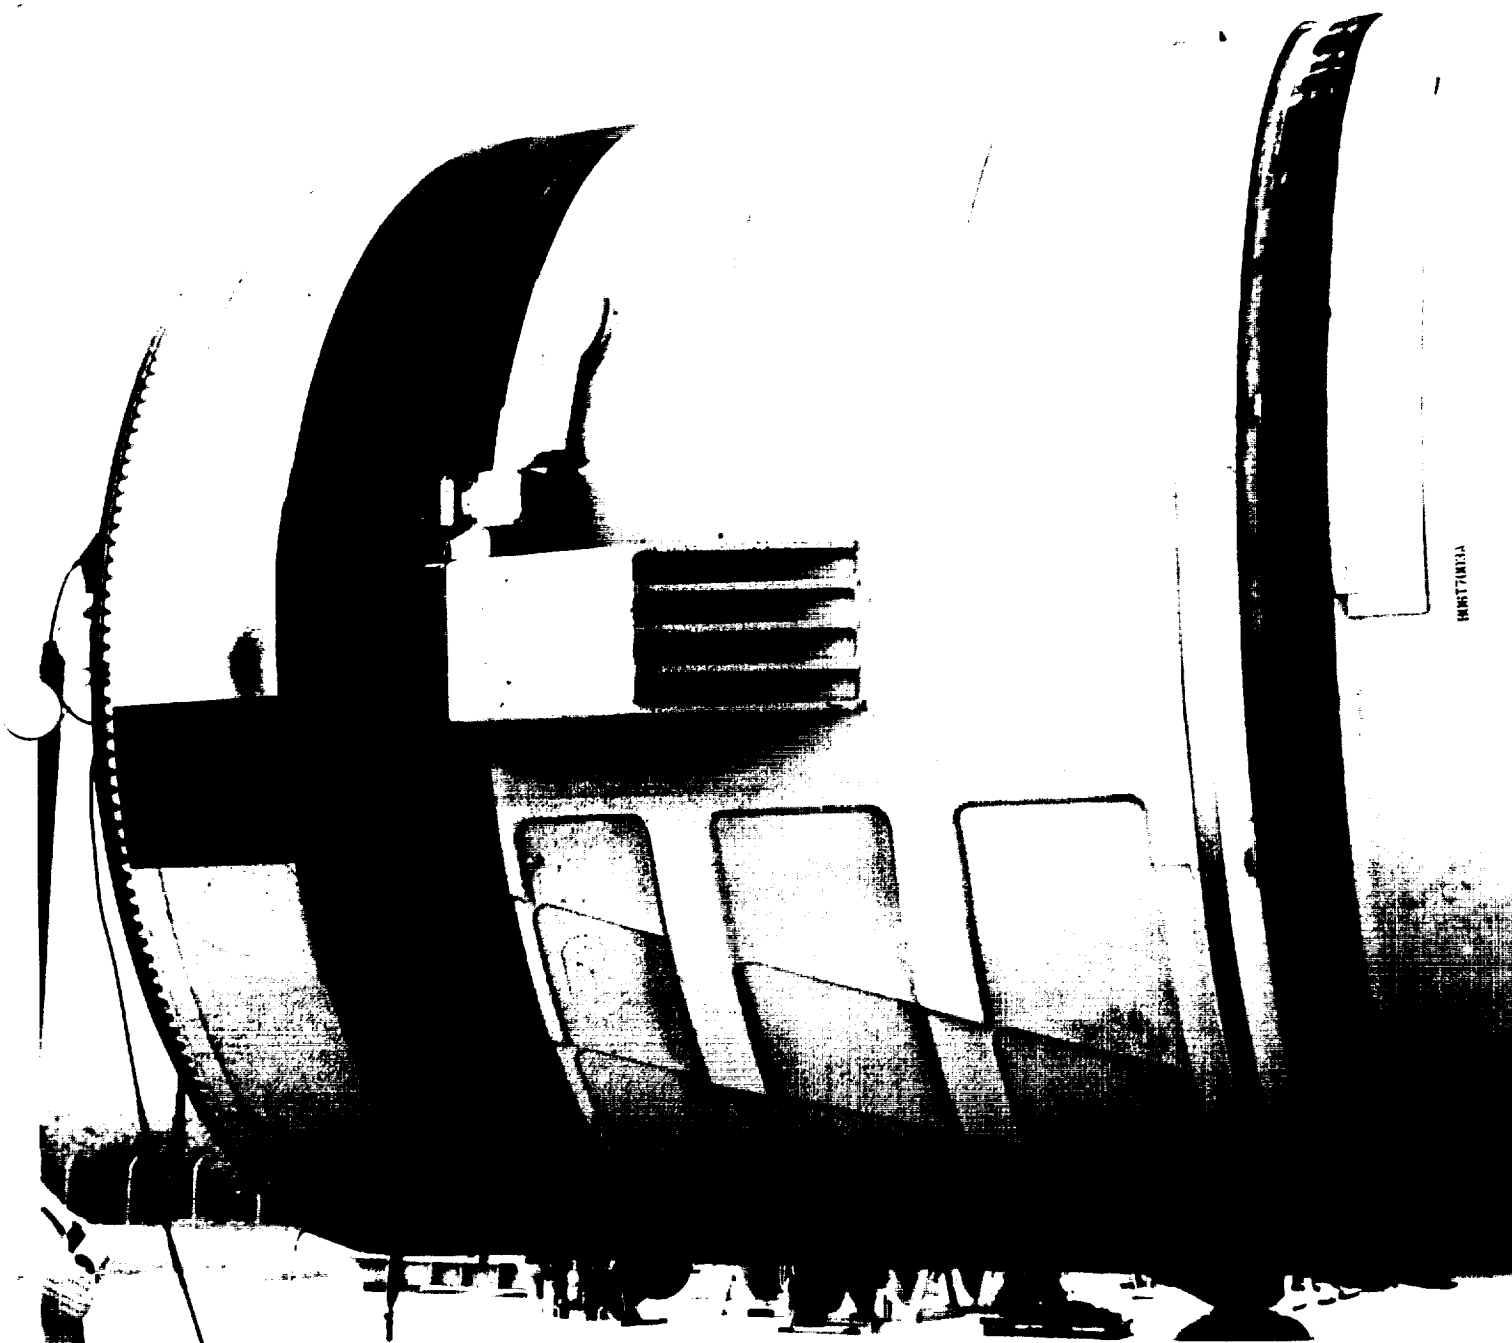
The LH forward skirt exhibited no debonds or missing TPS. Minor blistering of the Hypalon paint occurred in localized areas. Both RSS antenna covers/TPS were intact and undamaged.

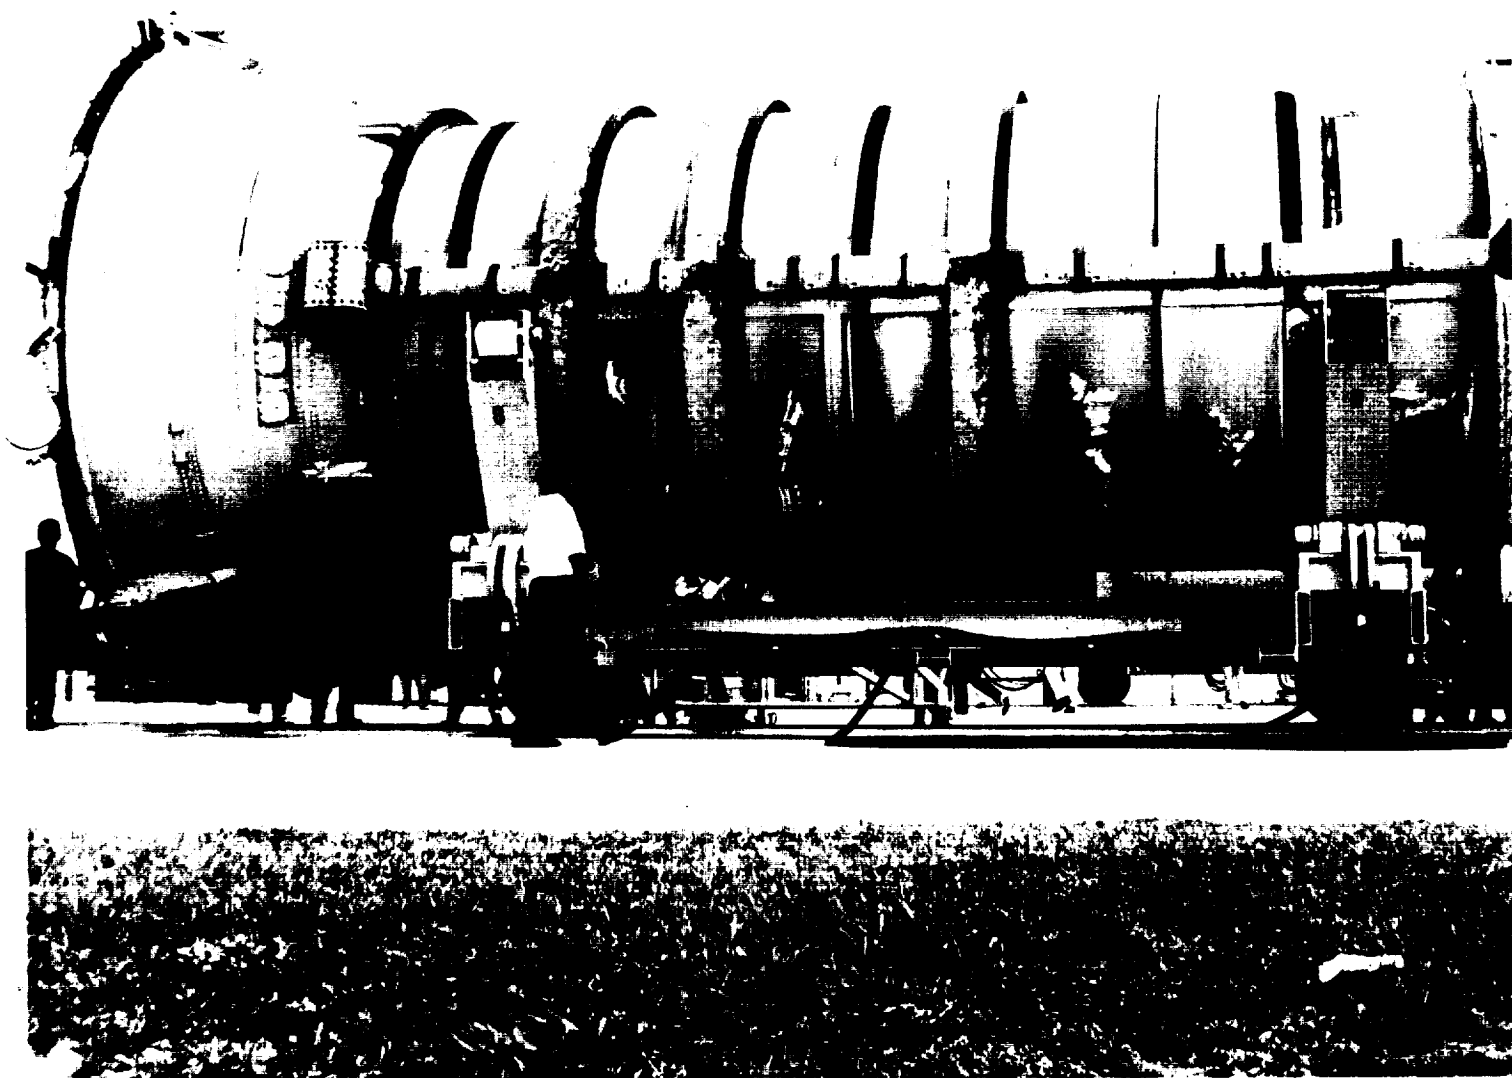
Post flight condition of the LH aft booster. The ET/SRB aft struts, ETA ring, IEA, and IEA covers appeared undamaged. All three aft booster stiffener rings sustained water impact damage

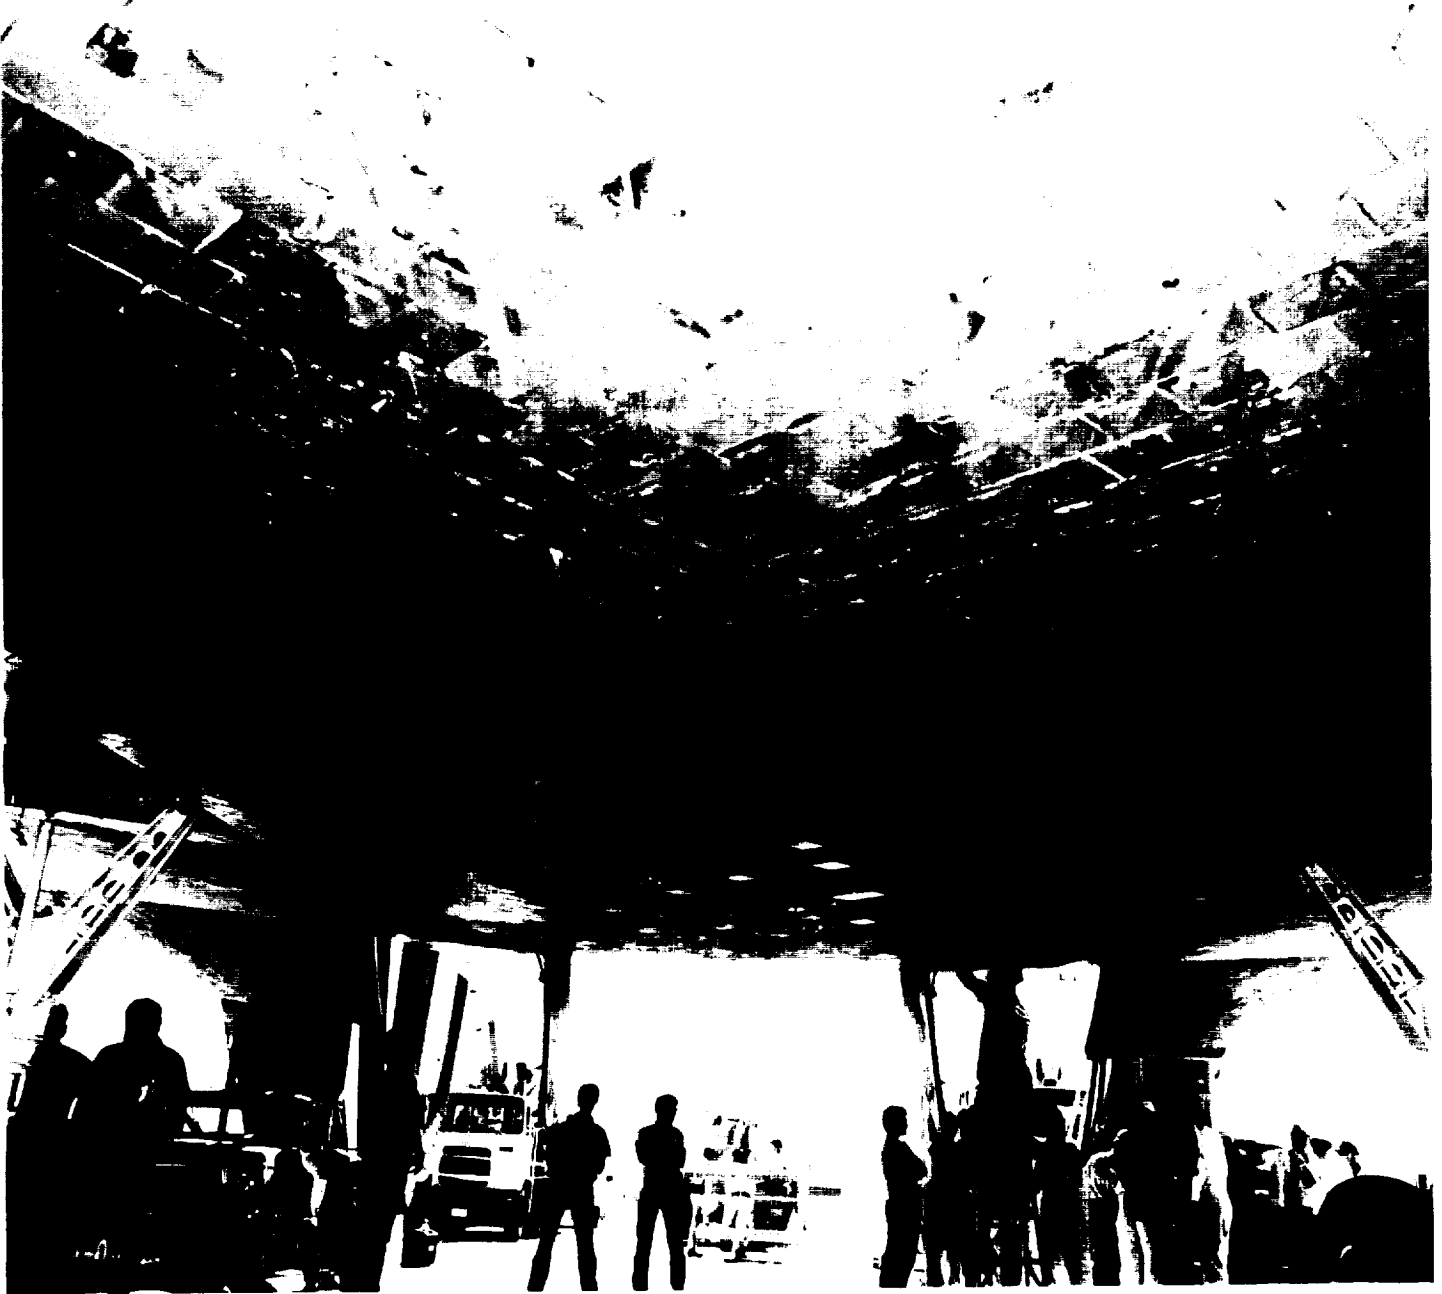
The Orbiter lower surface tiles sustained a total of 152 hits, of which six had a major dimension of 1-inch or greater. The distribution of tile damage hits does not suggest a single source of ascent debris, but indicates a shedding of ice and/or TPS debris from random sources.

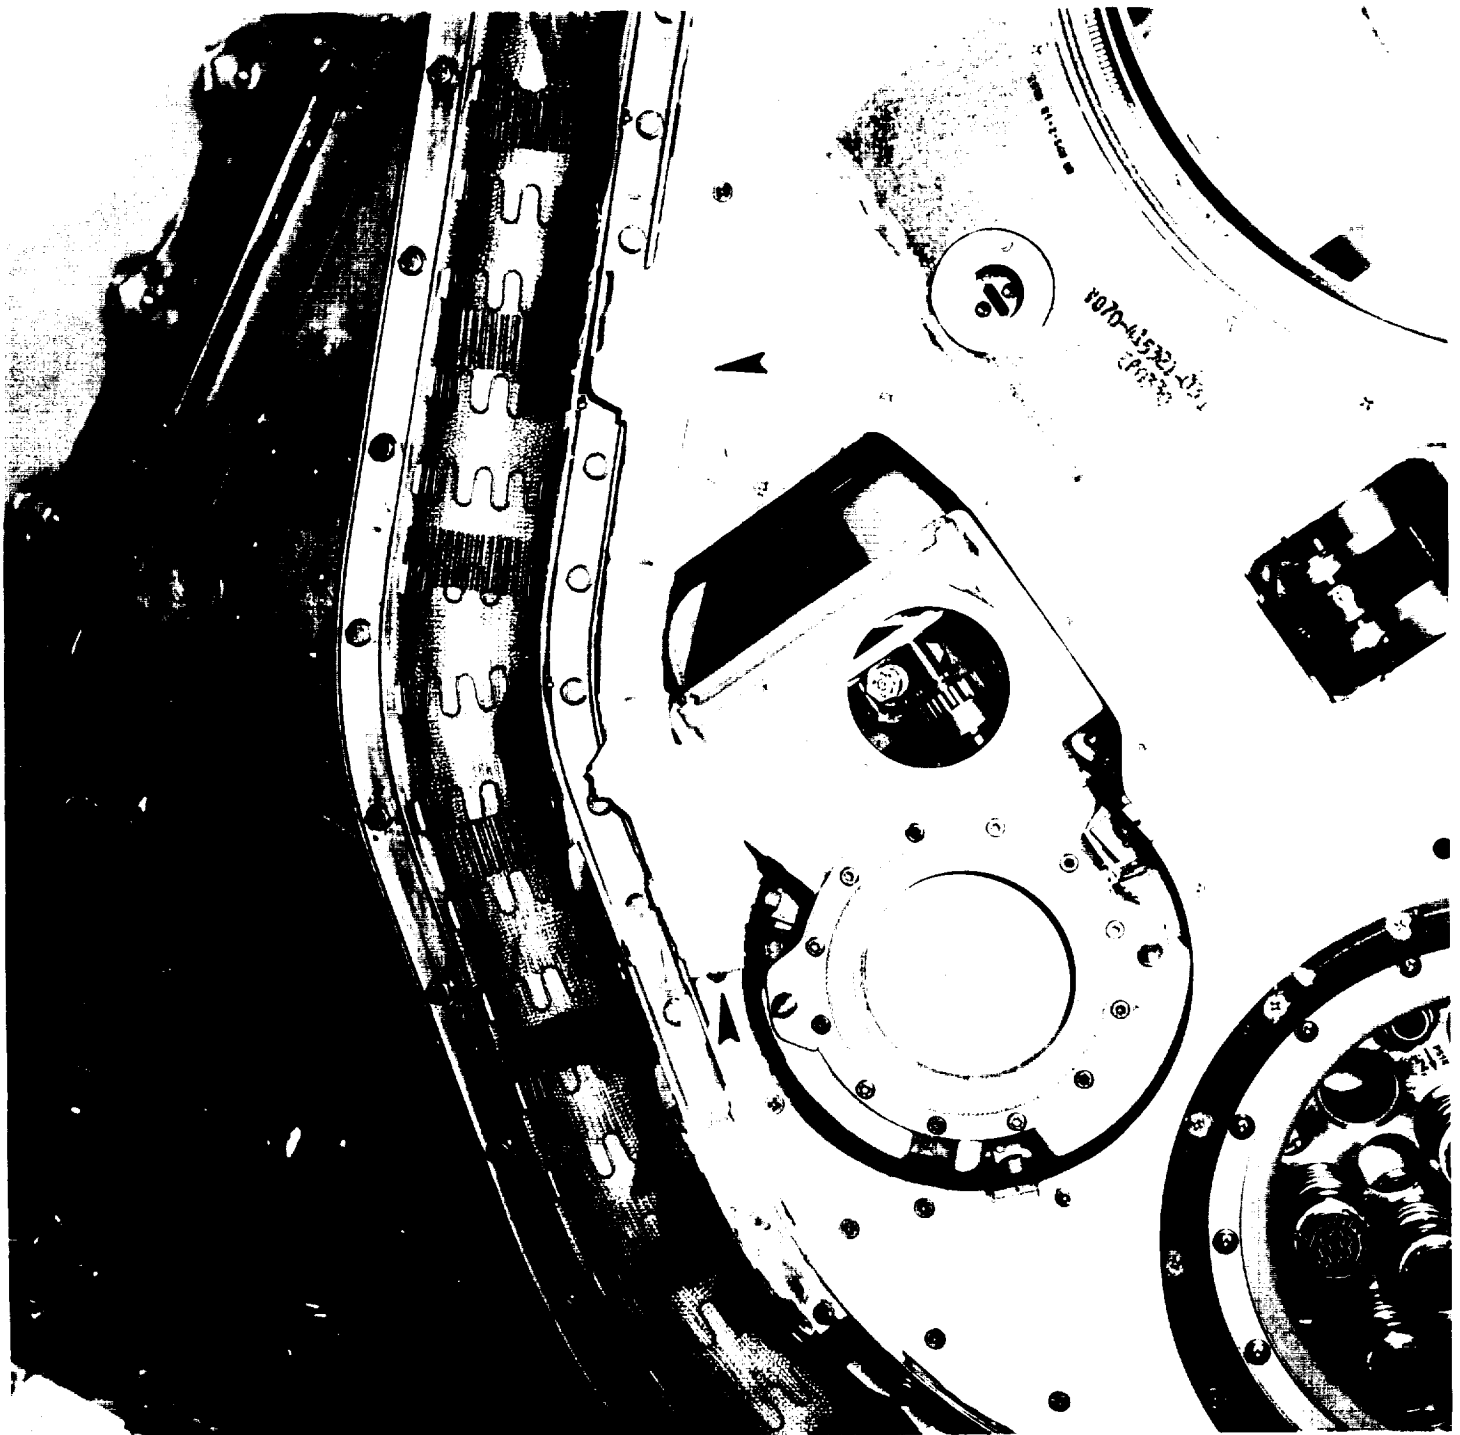
A section of the ET/ORB LH2 umbilical purge seal and closeout foam was still attached to the interface plate/disconnect. The missing section was visible in the separation camera films.

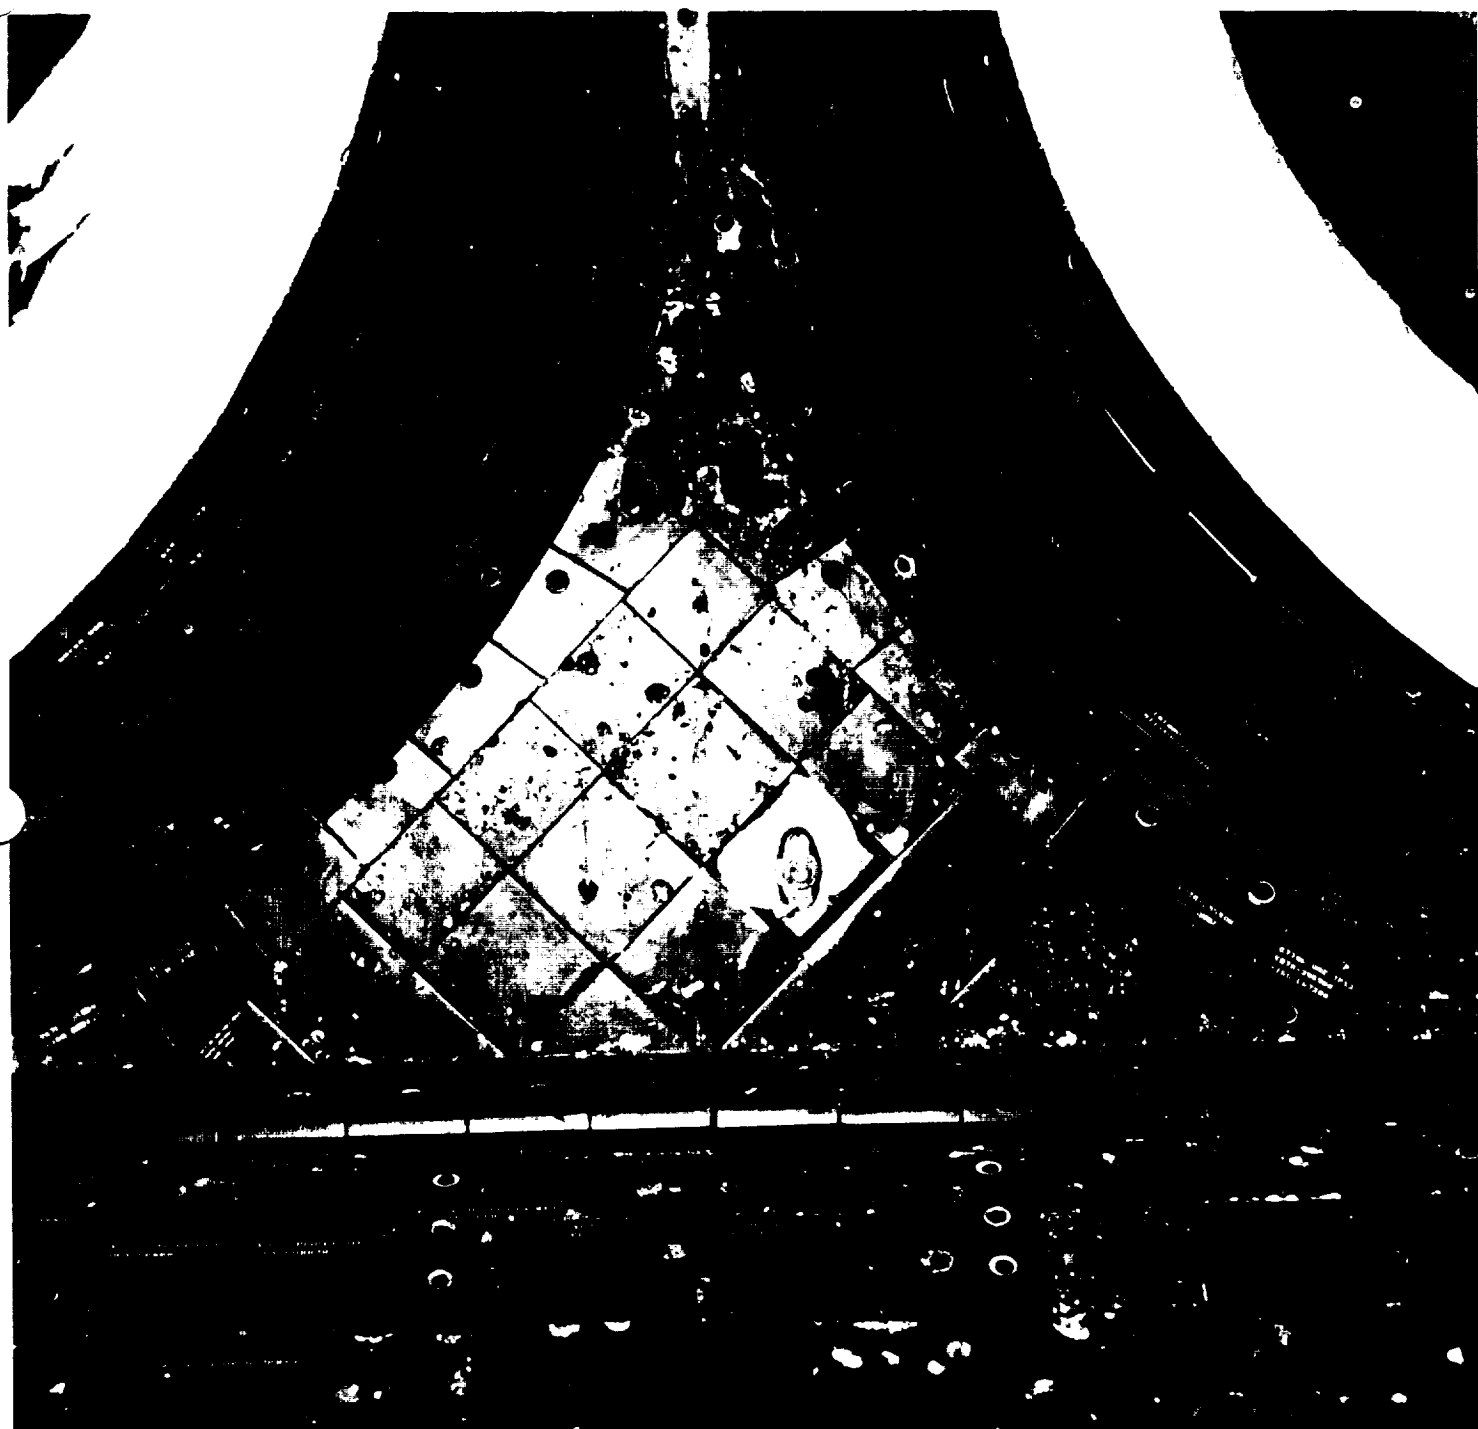
The majority of tile V070-395093-016 was missing from the base heat shield between SSME #2 and #3. This tile, which covers a calorimeter, sustained an in-plane failure, leaving the strain isolation pad and an attached layer (approximately 0.3 inches thick) of densified tile material in the cavity. An In-Flight Anomaly (IFA) was taken. In addition to the missing tile, an 8 by 6 by 0.5-inch tile damage site was present on the base heat shield adjacent to SSME #1 (at approximately the 7:00 o'clock position). This damage site appeared to have been caused by a dense object and may have been caused by the lost tile. This flight marked the fourth use of the Orbiter drag chute. The drag chute appeared to have functioned nominally. All drag chute hardware was recovered and showed no signs of abnormal operation. The only unexpected flight hardware found on the runway was a tile gap filler from the aft fuselage sidewall.

The majority of tile V070-395093-016 was missing from the base heat shield between SSME #2 and #3. This tile, which covered a calorimeter, sustained an in-plane failure leaving the strain isolation pad (SIP) and an attached layer of densified tile material in the cavity.

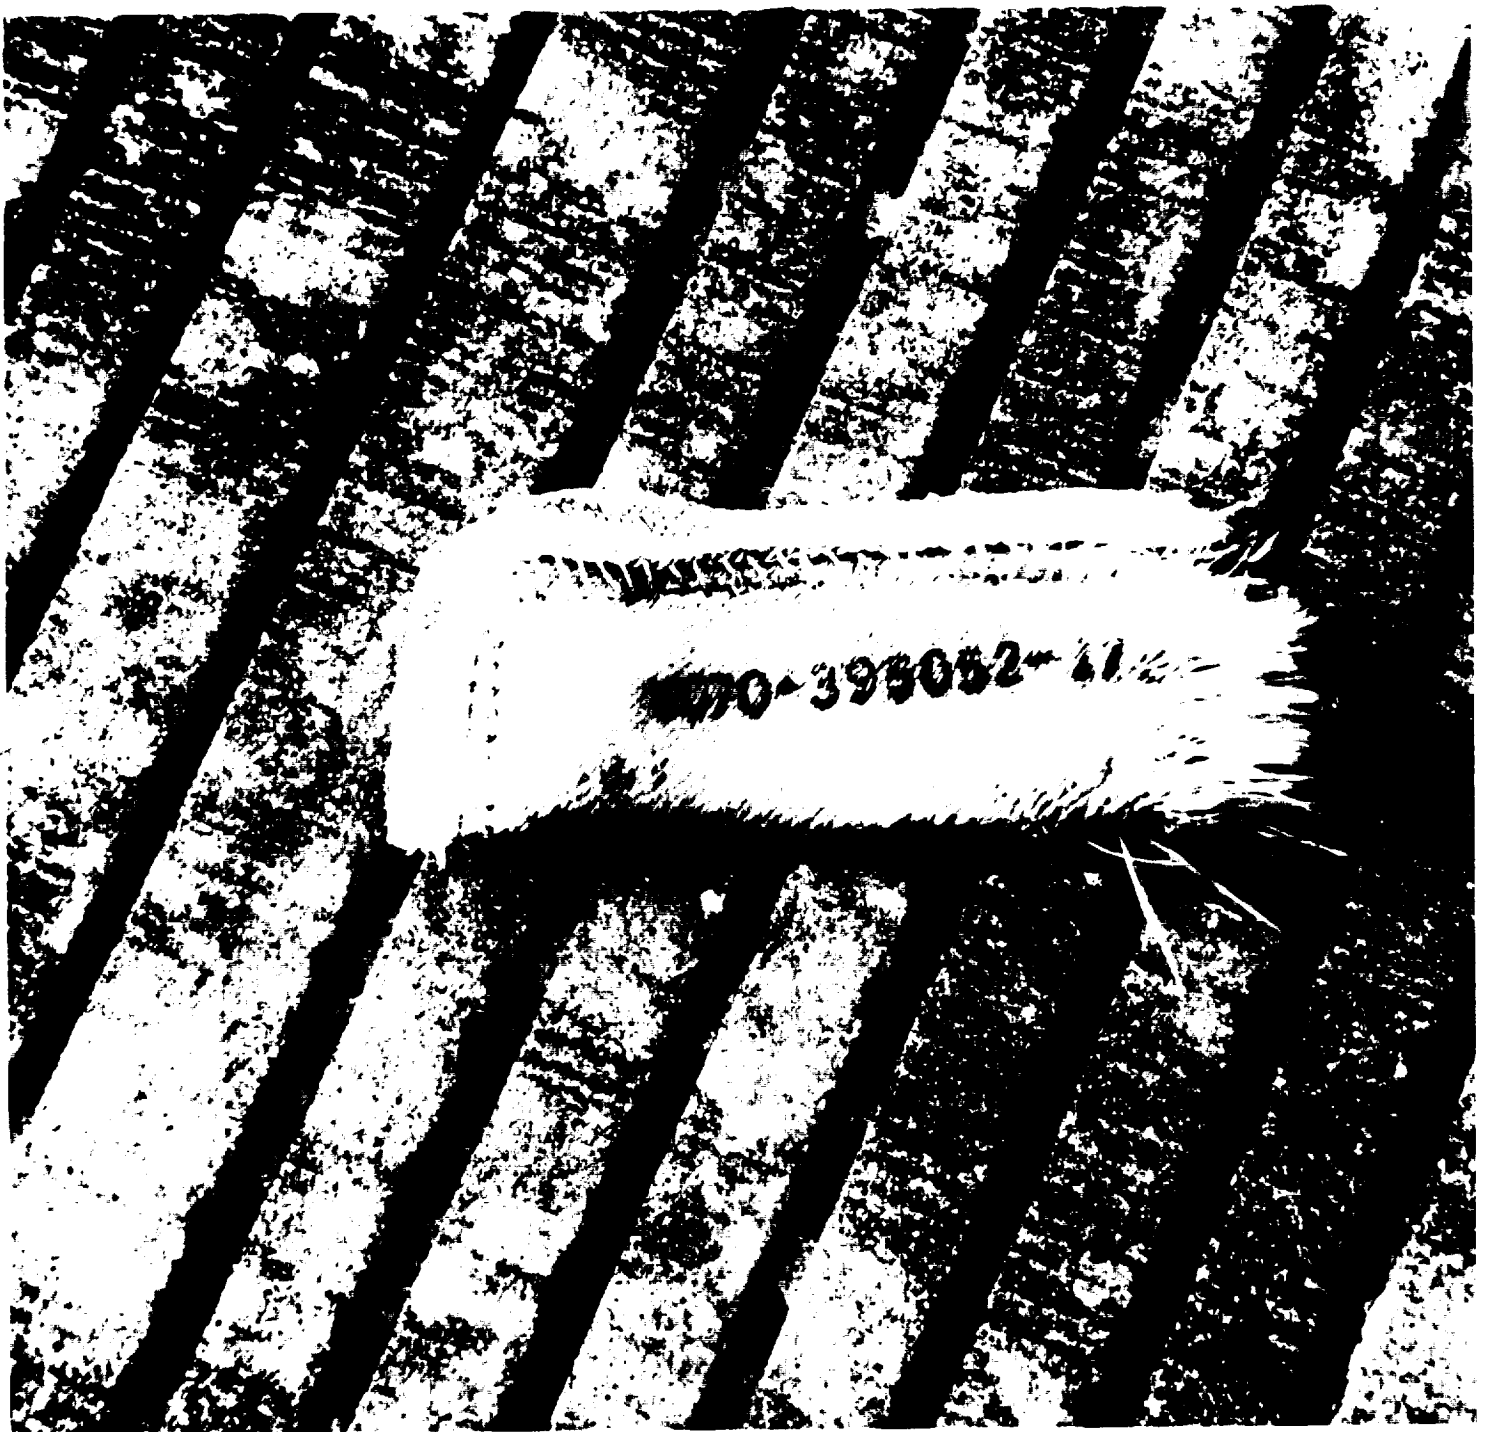
Inspection of Runway 33 immediately after landing revealed
a tile gap filler from the left aft fuselage sidewall.
